Lochluichart Estate

Flooding / Erosion Key Issues Report

November 2017

CLIENT: Lochluichart Estate LLP
PROJECT TITLE: Lochluichart Estate
REPORT TITLE: Flooding / Erosion Key Issues Report
PROJECT REFERENCE: 122917
DOCUMENT NUMBER: 122917-KIR

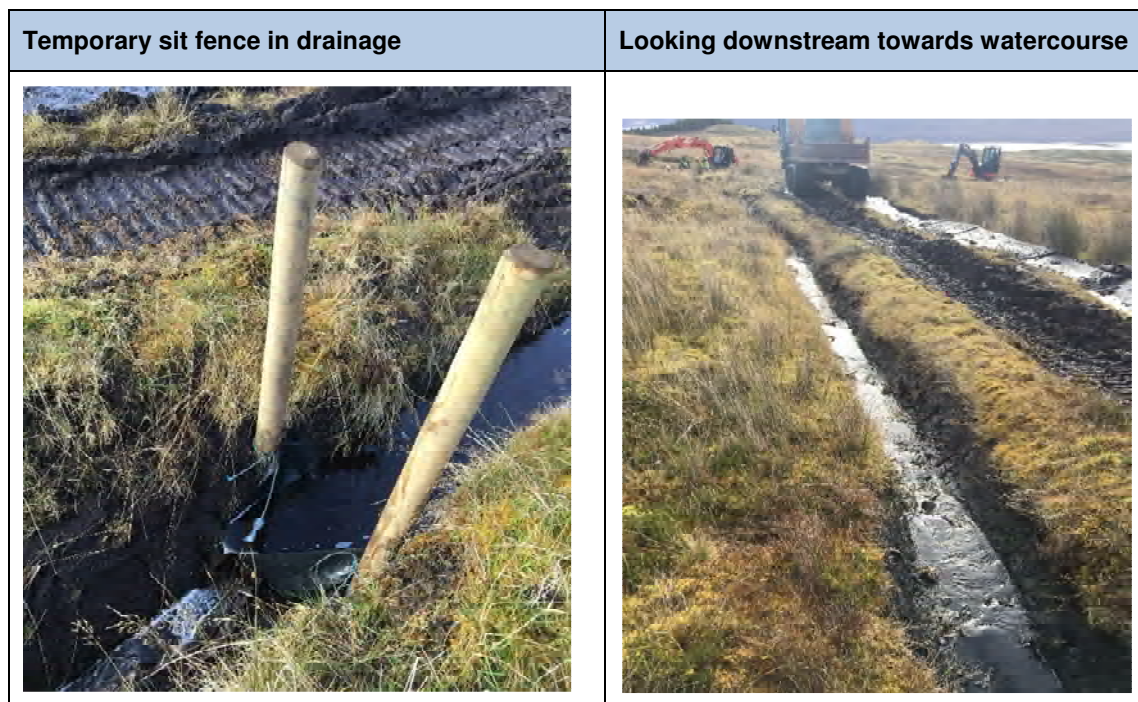
During both site visits, a pre-earthworks drainage ditch was observed along the Windfarm grid connection servitude. At the time of Site Visit 2, conditions were dry, but there were quite significant flows in the ditch which discharged directly into the watercourse at Reach 1.

The ditch had two effects: it introduced flows to the watercourse higher in the catchment than would naturally occur; and it concentrated flows as a point source thereby losing the attenuation effects of natural sub-surface or overland flow. Both of these factors contributed to higher flows in the watercourse than would have occurred prior to construction of the Windfarm.

Without mitigation, the conditions observed during Fairhurst's site visits would continue, and point source flows to the watercourse would be higher than during natural conditions before the Windfarm was constructed.

The purpose of the ditch was to reduce ground water levels and intercept surface water uphill of the grid connection servitude. However, as can be seen from the photographs, this had limited benefit with the servitude remaining wet and easily disturbed by tracked excavator.

During the Site Visit 2, Fairhurst recommended that the pre-earthworks ditch be infilled. This could be progressed using locally won materials and locally sourced forestry waste to create check dams at 3-5 metre centres extended to surface level. The check dams would allow the water table to return to

pre-construction levels, and allow surcharged flows to shed overland downhill rather as a point source to the watercourse within Reach 1.

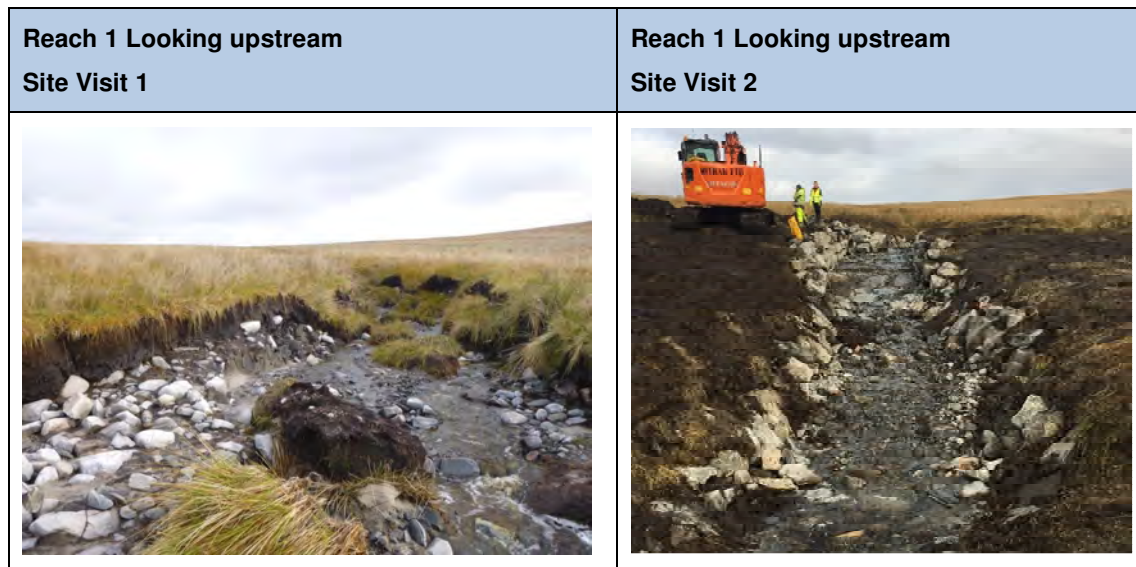
Significant erosion has occurred at the windfarm grid cable crossing as shown in the photographs below.

It is understood from the Client that, prior to the August 2017 flood event, the grid cable passed under the watercourse (constructed using open trench methods). The trench was backfilled, and a culvert was placed in the watercourse to allow formation of a servitude access. The flood event washed out the culvert crossing and eroded the channel exposing the cable marker tape.

During Site Visit 1, there had been no mitigation or protection work within Reach 1. By the time of Site Visit 2, a gabion mattress had been constructed over the grid connection cable to protect it from future erosion, and rip-rap stone had been placed in the banks and bed of the watercourse to stabilise the cross section.

While the works provide a localised solution to protecting the grid connection cable, the result was a linear, steep and smooth channel. The risk arising from this is the acceleration of water during higher flow events which has the potential to cause erosion downstream as the watercourse returns to its natural channel.

Reach 1 Looking downstream Site Visit 1	Reach 1 Looking downstream Site Visit 2

During the Site Visit 2 it was recommended that the constructed channel be further modified to include baffles and offset barriers using the rip-rap stone to create localised pools and small meanders in the stabilised section. These would act to reduce flow velocities, increase the flow length (and therefore reduce the gradient) and attract the deposition of bed material.

It was further recommended that the bank protection be narrowed and raked back to create an angle rather than a vertical face. This would allow the surfaces to be dressed with topsoil to encourage re-vegetation.

Performance of the re-constructed channel should be monitored on an ongoing basis to assess the regeneration of vegetation on the banks, and the stability of the natural channel downstream.

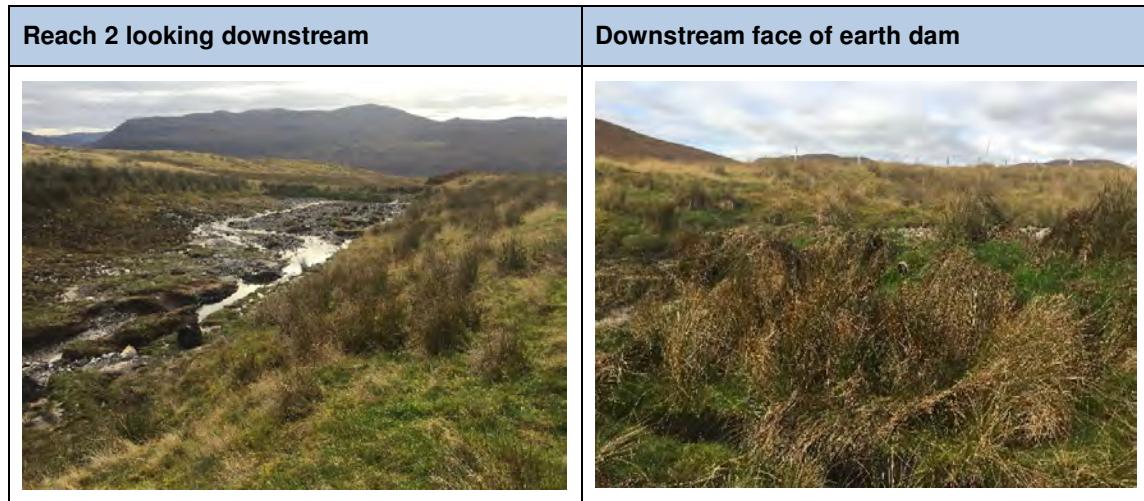
There is a significant quantity of sand and larger stones deposited across Reach 2 as can be seen in the photographs. This is likely to comprise previous build up behind the dam, and material washed down from Reach 1 during the August 2017 flood event.

The gradients in this section were relatively flat, and it is not considered that there was a risk of instability from erosion in the short term as the watercourse passed through this area.

However Reach 2 is immediately upstream of Reach 3 (described below), and there may be a longer term risk with continued erosion that the steeper gradients migrate upstream.

The natural / man-made bowl feature at Reach 2, along with the remains of the earth dam create the opportunity for the formation of flood storage at this location. Any solution would have the purpose of attenuating peak flows rather than storing water for the long term.

The area would be dry during normal flow conditions, and a constrained outlet would hold back a proportion of higher flows to reduce peak conveyance.

A detailed assessment of the storage area available against flows arising would be required to derive a design for a flow control structure, as well as consultation with SEPA to determine CAR requirements.

The structure itself would need to be of a simple / low cost nature, yet robust enough to contain flows and higher velocities. This might be achieved through the use of timber or concrete stop logs, or a stepped gabion arrangement to provide a narrowed notch or channel.

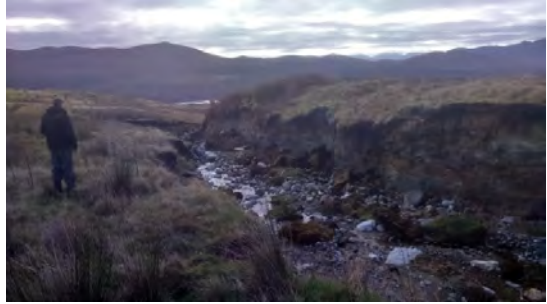
Heavy erosion was visible on the higher west bank in the upper sections of the reach, and in some sections this had been eroded to a height of 3 to 4 metres. There was evidence of cobbles and rubble that had been washed into the main channel during the August 2017 flood event.

Within much of the reach, the banks were loose and overhanging, and it was anticipated that material will continue to migrate downstream until a stable cross section and gradient is achieved.

In areas where the bank has been eroded to a slope of 1:1 or closer to vertical, the bank is likely to be unstable and a slip is likely.

The bed of the watercourse is unstable and movement during higher flows is likely.

Given the dynamic nature of this reach, it is recommended that local controlled works are undertaken to stabilise overhanging sections of banks with material used to reinstate the toe areas, encouraging establishment of existing vegetation. It may be necessary to fence off some sections for protection during periods of Estate activity.

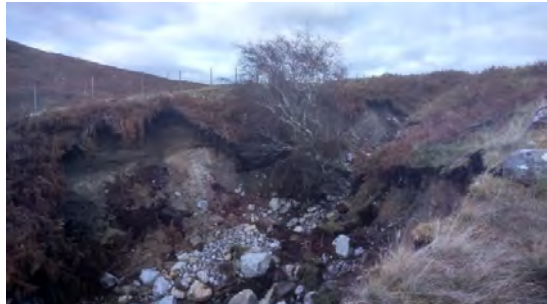
At the downstream extent of the reach before the confluence with another tributary, the channel narrows and the depth of the erosion increases.
